Diopter Pins Broke? Work It Won't!

OK, let's focus on the problem with AN/PVS-7B and AN/PVS-7D night vision goggles. The problem at hand is focus! Or, rather, a lack of focus due to busted diopter adjustment ring pins.

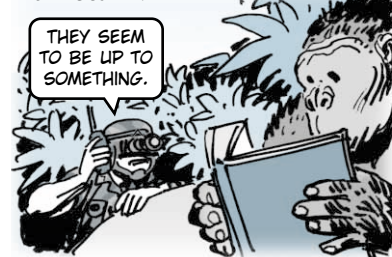
Unit repairmen, if you find diopter rings with broken pins, check the warranty expiration date on the warranty label on the front of the goggles. If your NVG is still under warranty, you're covered. If your NVG is out of warranty, you may be in luck. Certain older NVGs are covered under an extended warranty—good until the end of December. For more details on the extended warranty contact Lance Fujita at: DSN 654-1610 or (703) 704-1610; or e-mail him at: lance.fujita@nvl.army.mil.

If your NVGs and rear cover assemblies are still under warranty, or if they are covered under the extended warranty, follow the warranty return instructions in Section 1-7 of TM 11-5855-262-23&P-2.

To get a replacement rear cover assembly when the broken NVG is out of warranty, order a replacement through your normal supply channels.

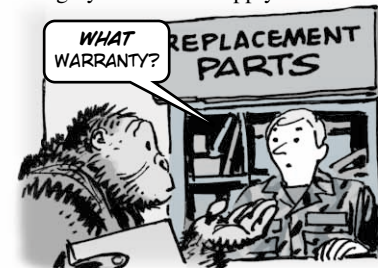
Don't try to piece together components of different rear cover assemblies to make one good assembly. There are several types of rear covers and they are not compatible with each other. You'll just create more problems. Wait until your new rear cover assembly arrives to use the NVG.
